February 2, 2016

21-1-22168-001

**RE: SOUTH KRAMER AVENUE LANDSLIDE: JACOBS CIRCLE TO
EMMONS STREET, SITKA, ALASKA**

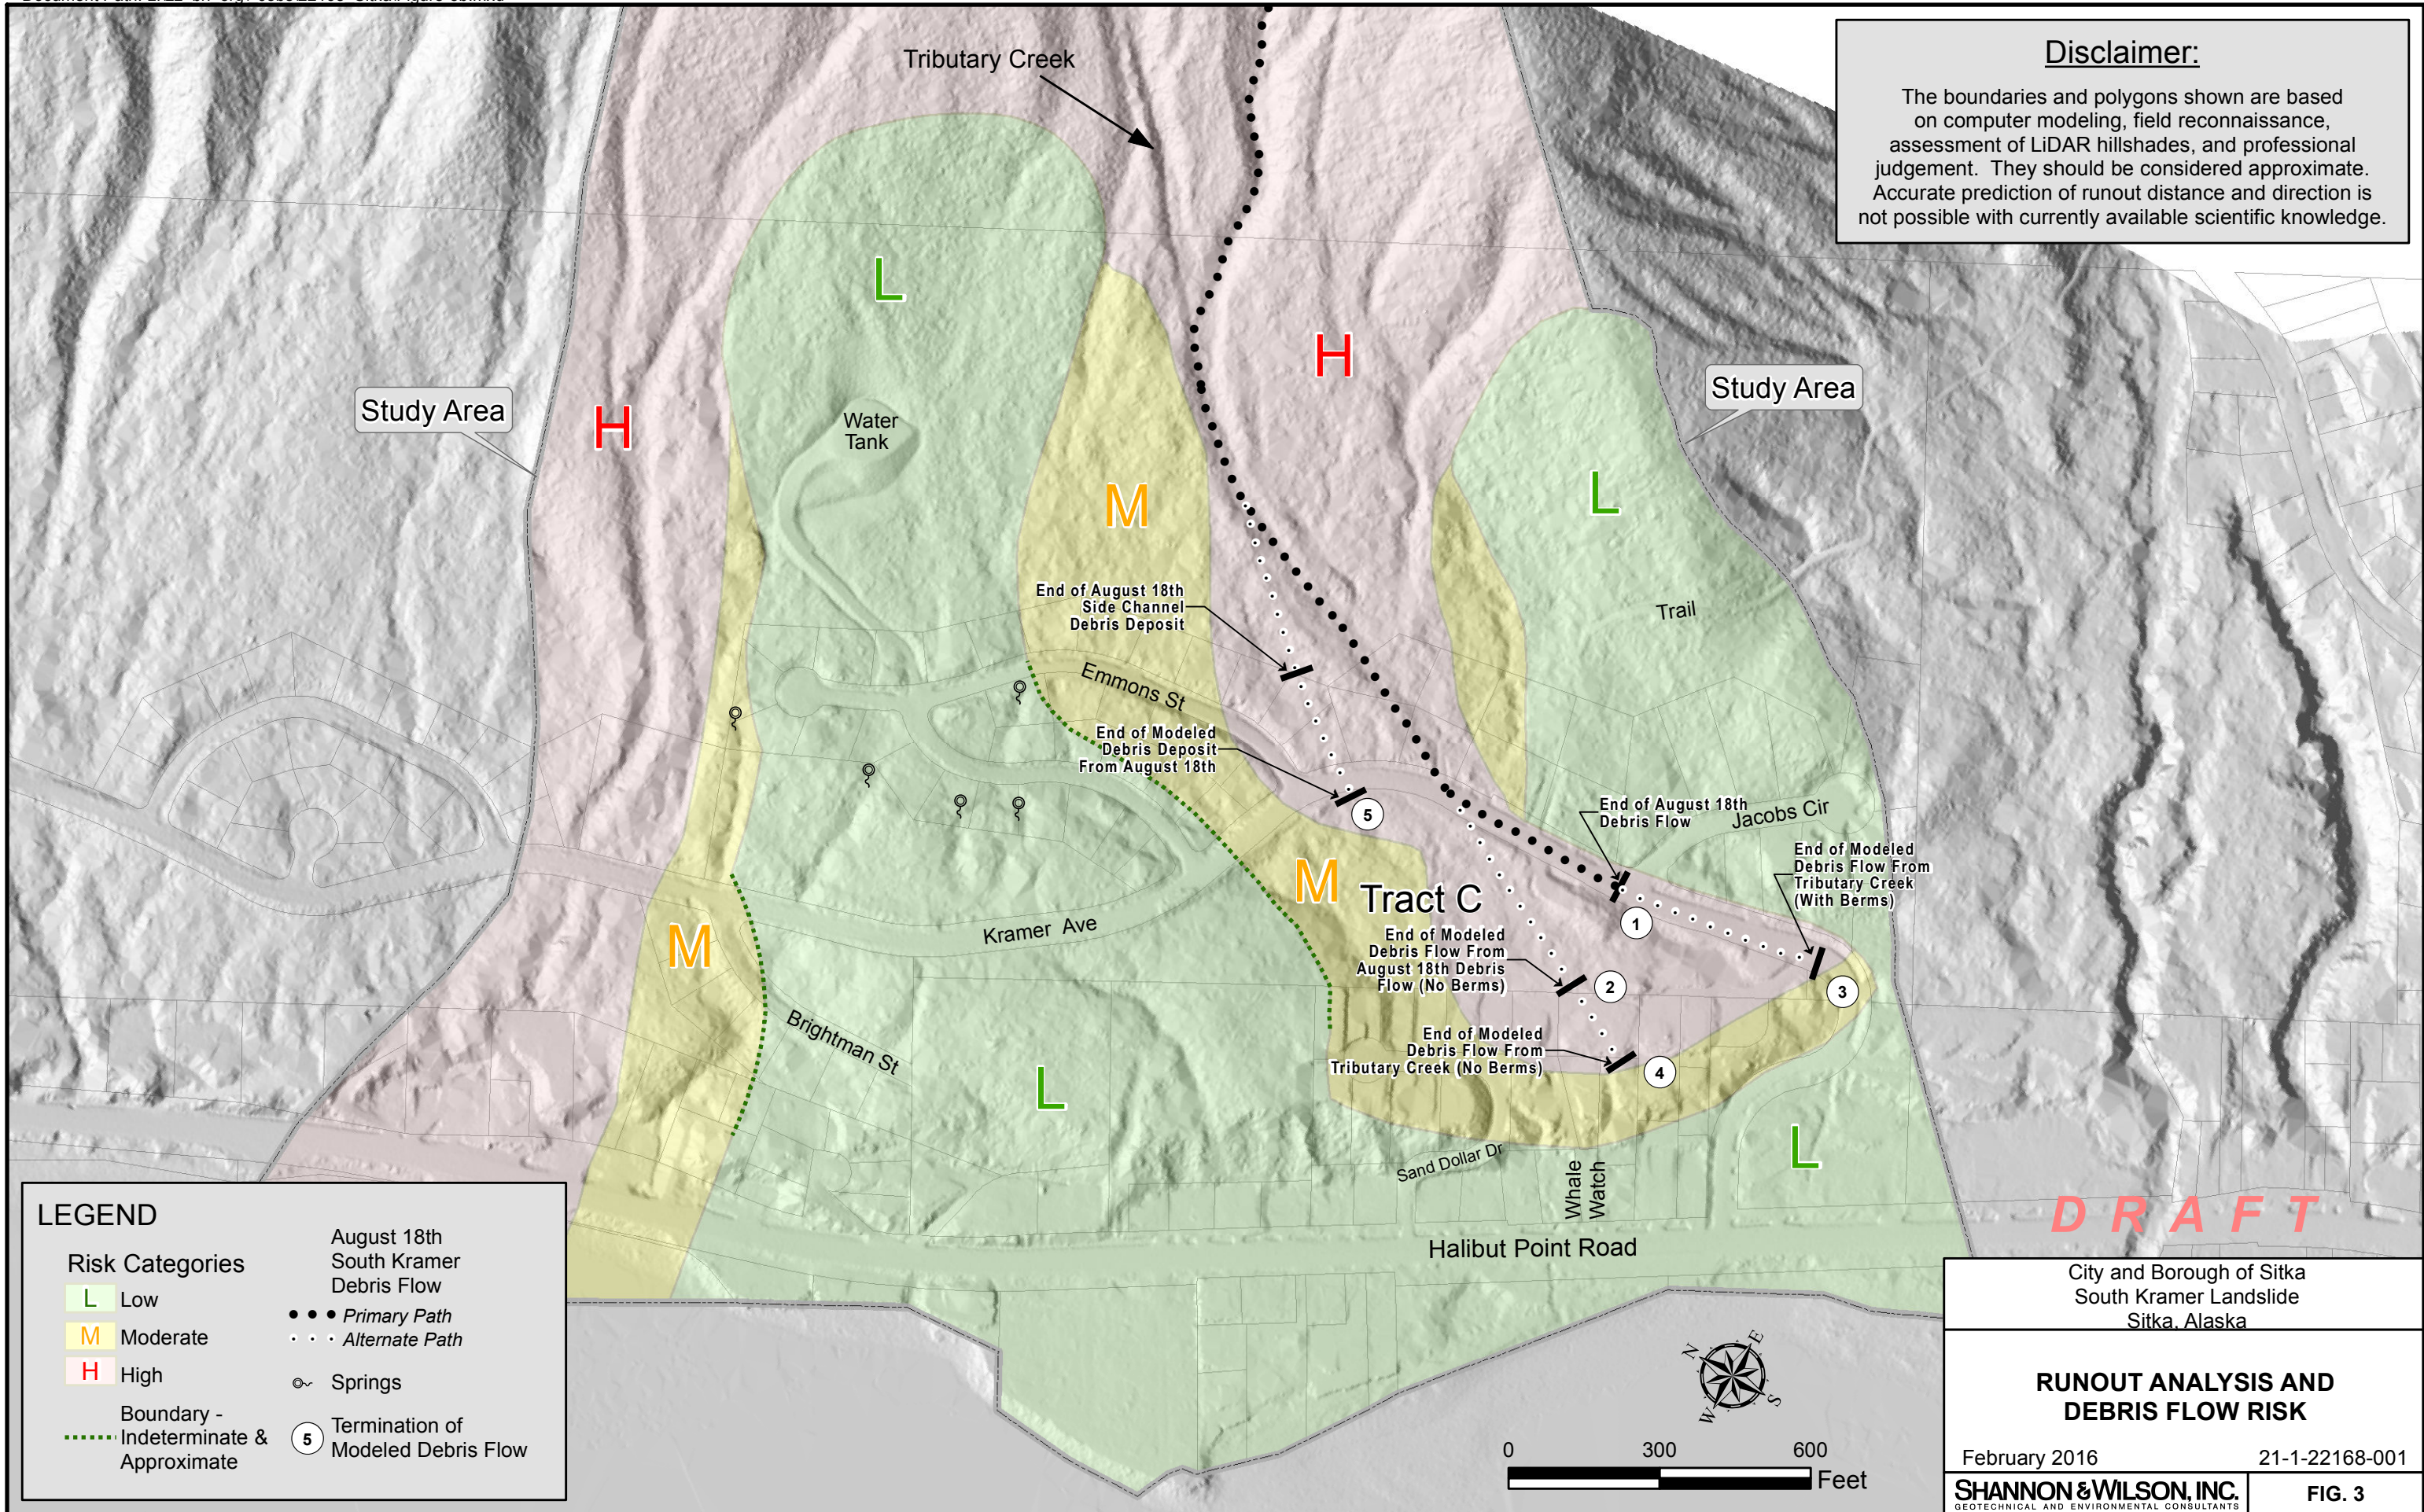
FIG. 3

The locations of the distal ends of the modeled runouts are presented in Figure 3. Modeling indicated that another debris flow along the August 18 alignment would end up in the same place as before, assuming that the berms on the west side of Kramer Avenue were left in place. If the berms were not in place on August 18, the debris could potentially have runout into Tract C about 400 feet southwest of Kramer Avenue. If the August 18 debris flow deposit had continued straight westward through the woods, as shown in Figures 2 and 3, it could have reached Kramer Avenue. Modeling of this side branch of the debris flow showed that once the debris flow material leaves the channelized section of the creek and becomes a uniform unchannelized slope, the debris slows and deposits relatively quickly, as shown in Figure 3. The modeling does not

The bedrock hollow in the August 18 initiation zone has mostly emptied out and the channel below has been scoured, so the future hazard from that source is likely low; however, a tributary creek/hollow to the north that extends to the top of Harbor Mountain has the potential to fail and recreate a similar or larger debris flow than the August 18 event. This bedrock hollow is about 700 feet higher in elevation than the initiation zone of the August 18 debris flow.

If this higher bedrock hollow failed in a manner similar to the August 18 debris flow, the model predicts that it would flow down Kramer Avenue about 400 feet beyond the Kramer Avenue debris deposit, assuming the berms were in place. Without the berms in place, this modeled debris flow would move about 580 feet southwest of Kramer Avenue, reaching residences on the eastern side of Whale Watch Drive and Sand Dollar Drive.

Based on our assessment of the modeling, field observations, and LiDAR images, we have created three categories of risk in the Jacobs Circle/Emmons Street area for debris flows originating on Harbor Mountain. The three categories described below range from high to low. There are **no** no-risk zones in the study area.

The high-risk zone is in and adjacent to the recent debris flow path and two other debris flow paths that were identified in the field and on the LiDAR hillshade image. They have incised channels and uneven, hummocky, and lobate topography. We recommend no new residential development or transportation and utility corridors through this area without extensive study and protective measures. If any new development or redevelopment is contemplated for these areas, a geotechnical evaluation should be performed by a licensed civil engineer specializing in

Three moderate risk zones were identified, as shown in Figure 3. They are either buffer areas between high- and low-risk zones, or areas that offer slightly higher risk than low, as discussed below. One is the buffer zone adjacent to the debris chute high-risk zone on the northern edge of the study area. Another buffer zone is located downhill (west) of Tract C. Another moderate zone is located uphill of Emmons Street where there appear to be deposits of ancient, relict debris flows. The channel that originally supplied debris to this area is presently incapable of delivering debris to this same area, in our opinion; however, if the adjacent incised creek/swale should become blocked during a debris flow, the relict channel could potentially deliver debris to this area again. If any new development or redevelopment is contemplated for these areas, a geotechnical evaluation should be performed and reviewed in the same manner as recommended above for high-risk zones.

The low-risk debris flow zones are areas that are unlikely to be impacted by debris flows; however, they should be evaluated by a professional, as described above to confirm that condition. They may be subject to other geotechnical issues such as local slope instability, high groundwater level, spring seepage, and soft ground.

geotechnical practice or professional geologist experienced in mass wasting processes. The evaluation should include subsurface explorations, evaluation of the hazard and risk from debris flows, and design of debris flow mitigation or protective measures. Such reports should be reviewed by a third-party for completeness and appropriateness.

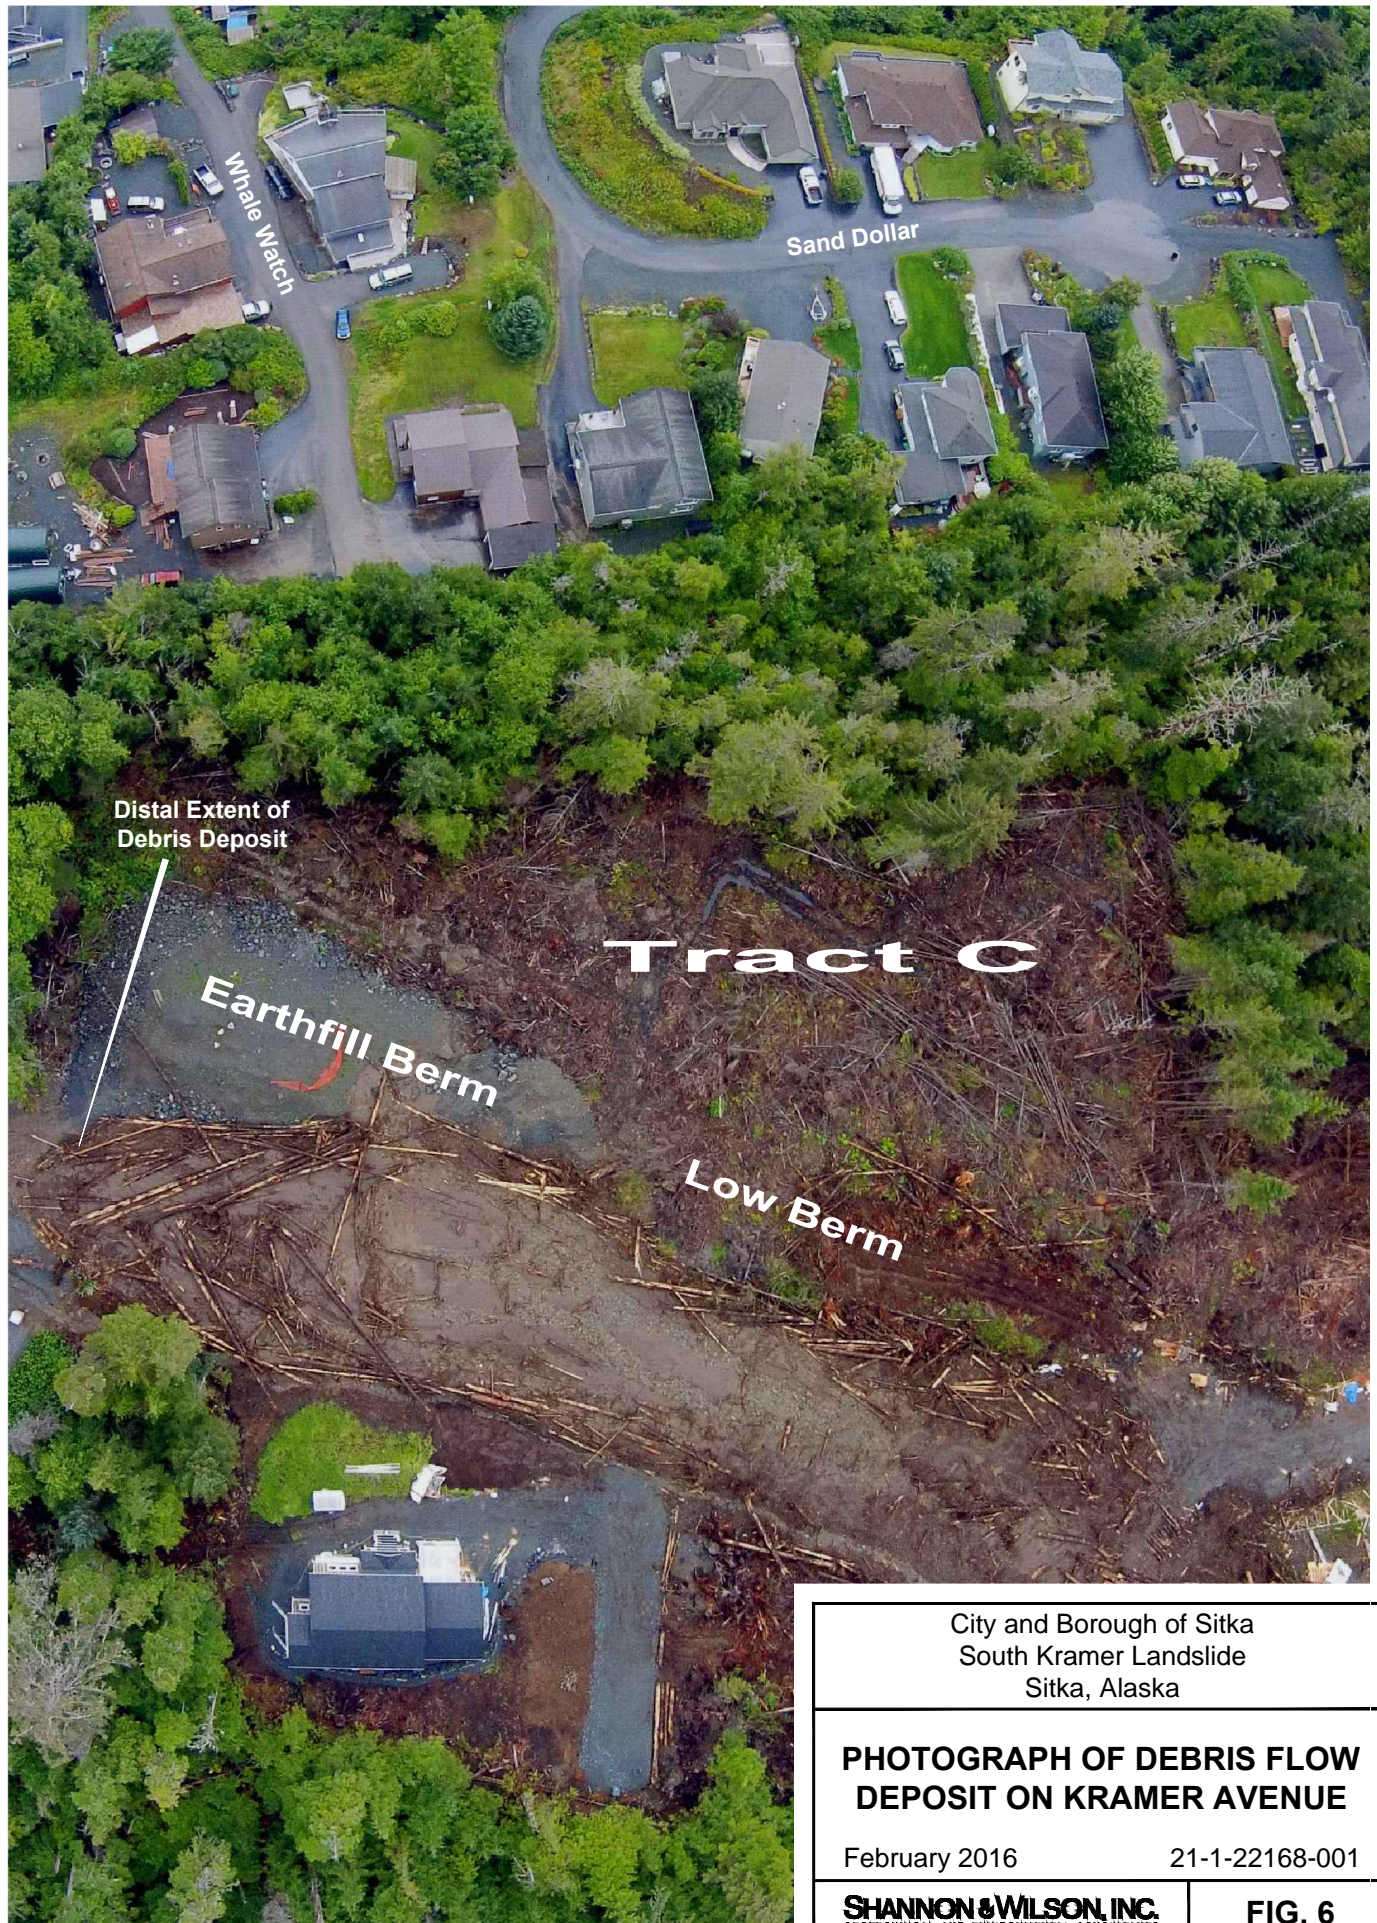
FIG. 6

From aerial photographs and from field observations, it appears that the first pulse of the debris flow left the channel and plowed into the woods near elevation 240 feet, as indicated in Figures 2 and 3. This was likely the result of an upslope, straight segment of the channel and the debris wanting to maintain a straight line. After the first pulse, the bulk of the debris followed the existing channel that was directed toward the residence at 430 Kramer Avenue. The debris killed three people, and destroyed one residence and damaged another. Upon reaching Kramer Avenue, the debris encountered a low berm on the south side of the road that appears from photographs to have been 2 to 3 feet higher than Kramer Avenue. Farther south along the western side of Kramer Avenue, fill was mounded 8 to 10 feet high in an earthfill berm. When the debris flow encountered these berms, it turned southward down the road. It came to a stop about 400 feet from the point at which it reached Kramer Avenue, as shown in Figures 2, 3, and 6.

We understand that the more southerly earthfill berm (Figure 6) is a temporary stockpile of soil that was placed by the development contractor for future site grading in Tract C.
