National Transportation Safety Board

Aviation Accident Final Report

| Location: | Kake, Alaska | Accident Number: | ANC19FA012 |
| Aircraft: | Beech 200 | Aircraft Damage: | Destroyed |

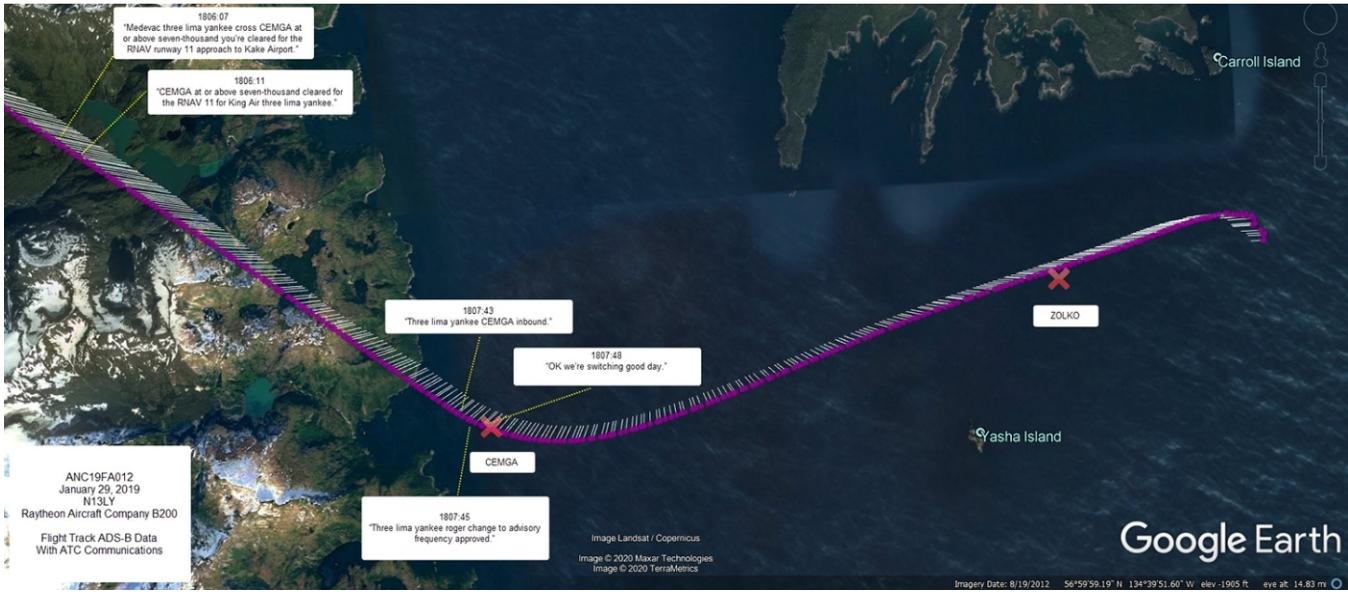
A review of archived FAA radar and ADS-B data revealed that the accident airplane crossed the CEMGA waypoint on the RNAV runway 11 approach at an altitude of about 7,000 ft above mean sea level (msl), then turned northeast and crossed the ZOLKO initial approach fix about 5,000 ft msl. The airplane then initiated a gradual descent and continued northeast toward the JOJOE intermediate fix. About 1810, while the flight was between ZOLKO and JOJOE, the airplane entered a right turn toward a southerly heading and began a rapid descent, losing about 2,575 ft of altitude in 14 seconds. The last radar data point was at 1810:36 when the airplane was at 1,300 ft msl and heading 143° with a ground speed of 174 knots. (See figure 1 and figure 2.)

Figure 1 - ADS-B track of the accident airplane with air traffic communications for the approach clearance.

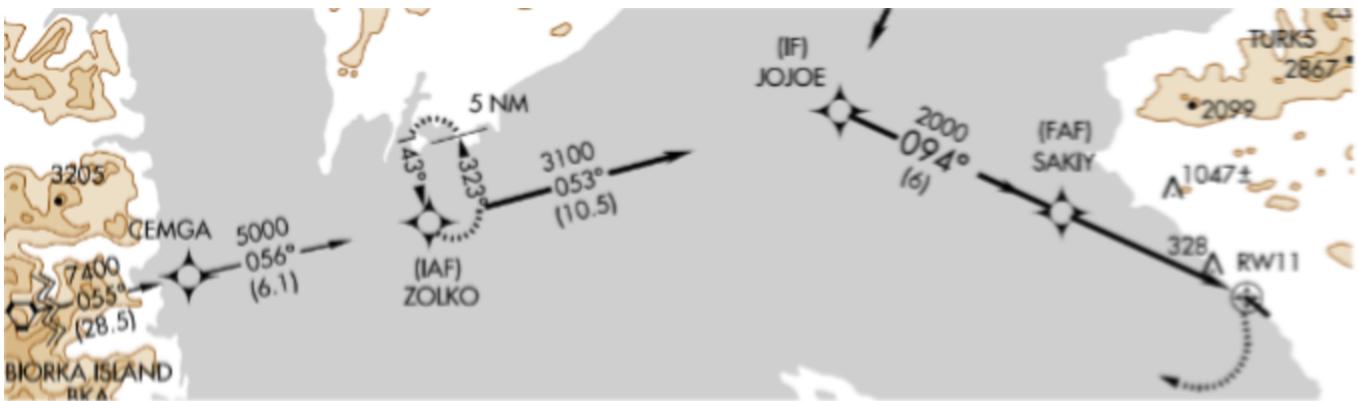
Figure 2 - Excerpt RNAV (GPS) RWY 11 Approach PAFE.

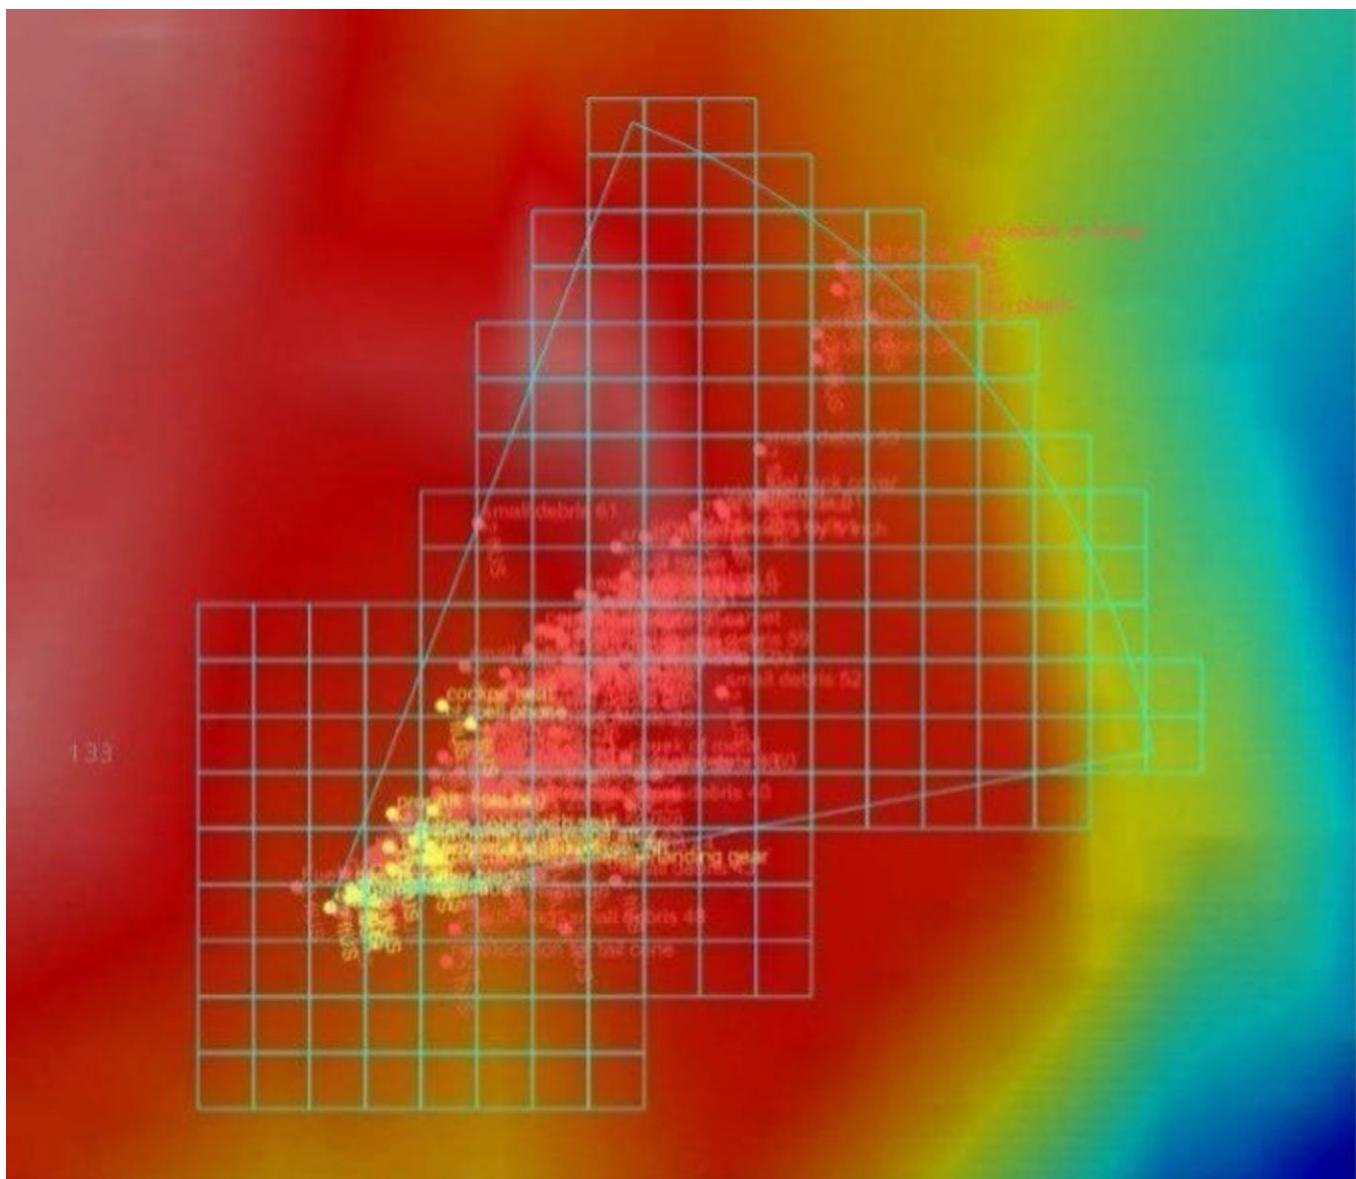
The airplane impacted the ocean waters of Frederick Sound and was located with the assistance of a remote operated vehicle (ROV) on March 19, 2019, at a depth of about 500 ft. A cone shape debris field spanned about 1,650 ft on a bearing of 45°, with the lighter debris farther northeast due to the ocean current. (see figure 3.)

Figure 3 - Debris field figure produced by TerraSond courtesy of Alaska Claims Services, Inc.
