Sitka Land Suitability and Feasibility Study

Phase I Summary and Recommendations

PND Project No. 242091

CBS LAND SUITABILITY AND FEASIBILITY STUDY – PHASE I SUMMARY REPORT

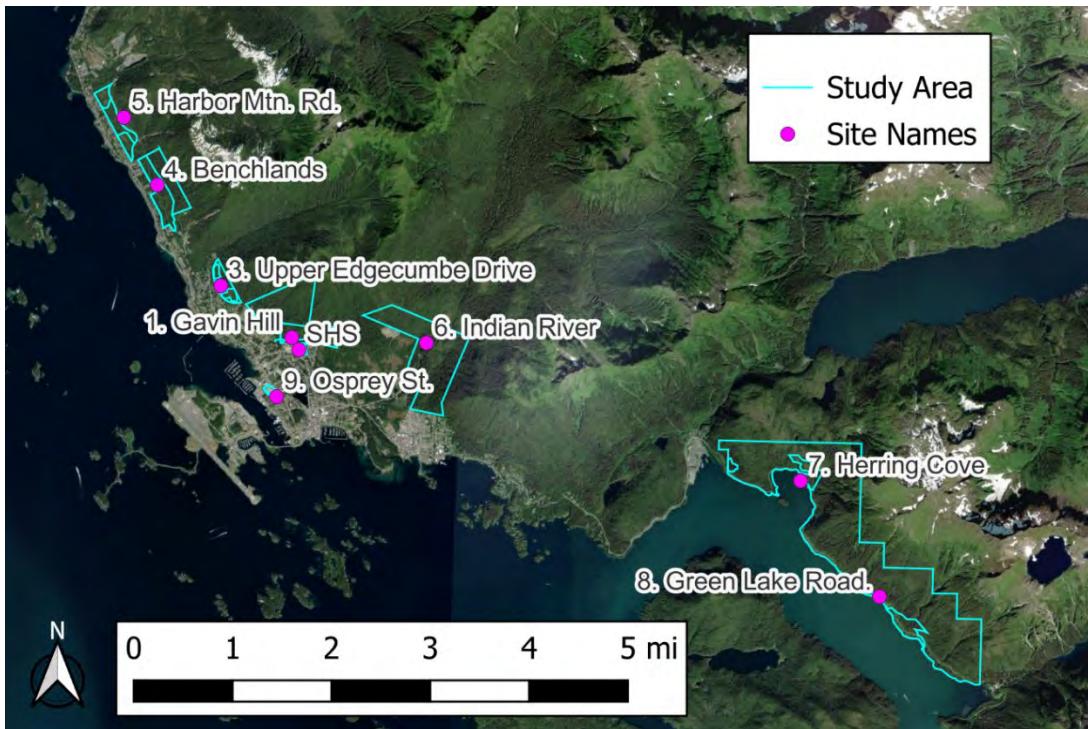
Figure 1 - Study Areas

- Gavan Hill
- Sitka High School
- Upper Edgecumbe Drive
- Benchlands
- Harbor Mountain Road
- Indian River (reviewed for access road construction)
- Green Lake Road
- Herring Cove Peninsula
- Osprey Street

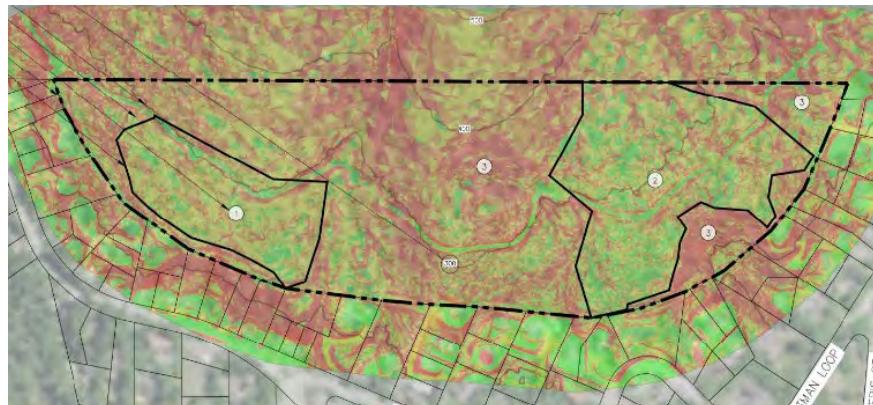
Figure 4 - Upper Edgecumbe Drive Site

- Sitka High School: The developable area east of the High School lies outside the modeled worst-case debris flow footprint. Slide Risk Score: 1.
- Upper Edgecumbe Drive: Although shallow slopes exist in portions of the site, steep terrain immediately east presents potential debris flow generation zones. Further detailed hazard analysis would be required prior to development. Slide Risk Score: 3.

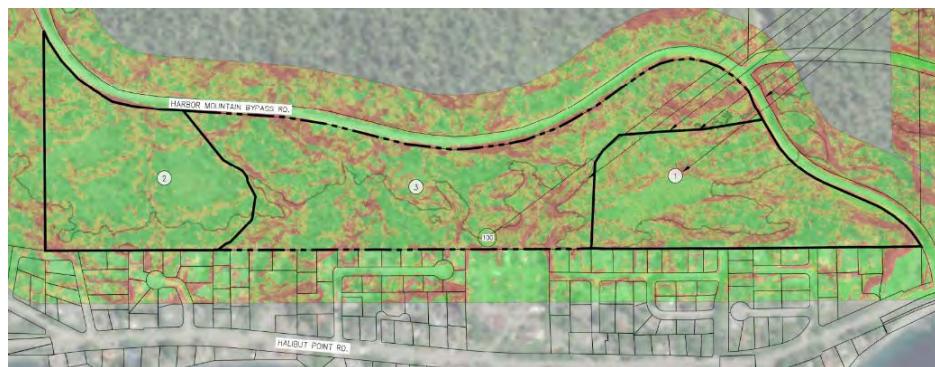
Figure 5 - Harbor Mountain Road Sites

- Harbor Mountain Road: Site 1 and Site 2 have relatively shallow grades within the polygons shown in the figure below and are conducive to development from that standpoint. Steep grades that could potentially produce landslides and/or debris flows are located east of the developable sites; however, the shape of the upslope terrain tends to promote landslide/debris flow material to travel to the east of the sites according to the TerrainWorks mapping. Slide Risk Score: 2.

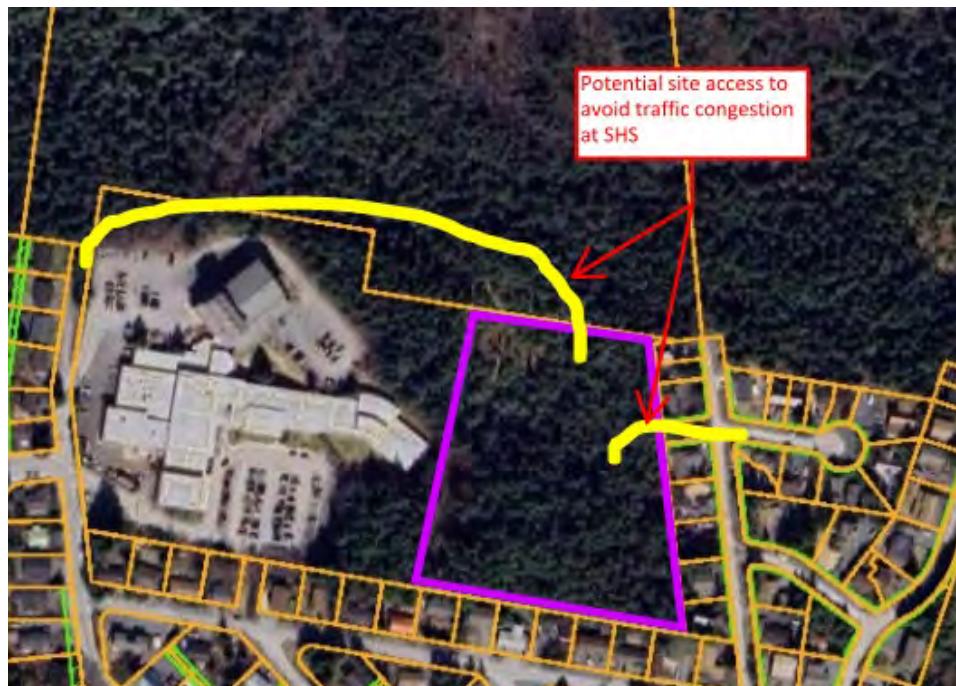
Figure 1: Potential site access routes to Gavan-SHS parcel

- i. Potential for high density housing in this area.
- ii. Adding housing here would increase the traffic in the vicinity of SHS significantly. Need to consider additional access points to the property.
- iii. Undeveloped right of way to the east of the parcel that could connect the property to Bahrt Circle. The R.O.W. appears pretty narrow from initial observations, but may represent a good secondary access to this area.
- iv. May also be able to add on to Lake Street Extension to provide access to this site from the north side of SHS. There is an anadromous stream that would likely need to be crossed in order to make this a viable access route (Figure 1).

- v. No major issues for connecting utilities for this area, but we need to assess if the existing utilities have enough remaining capacity for whatever the proposed development ends up being.
- vi. There is a 6-inch water line on Verstovia Avenue (plan south of parcel) that should have plenty of remaining capacity.
- vii. May be able to add some of the SHS property to this parcel to increase the developable area.
- viii. Likely some existing subsurface data from the construction documents for the PAC located just north of SHS.

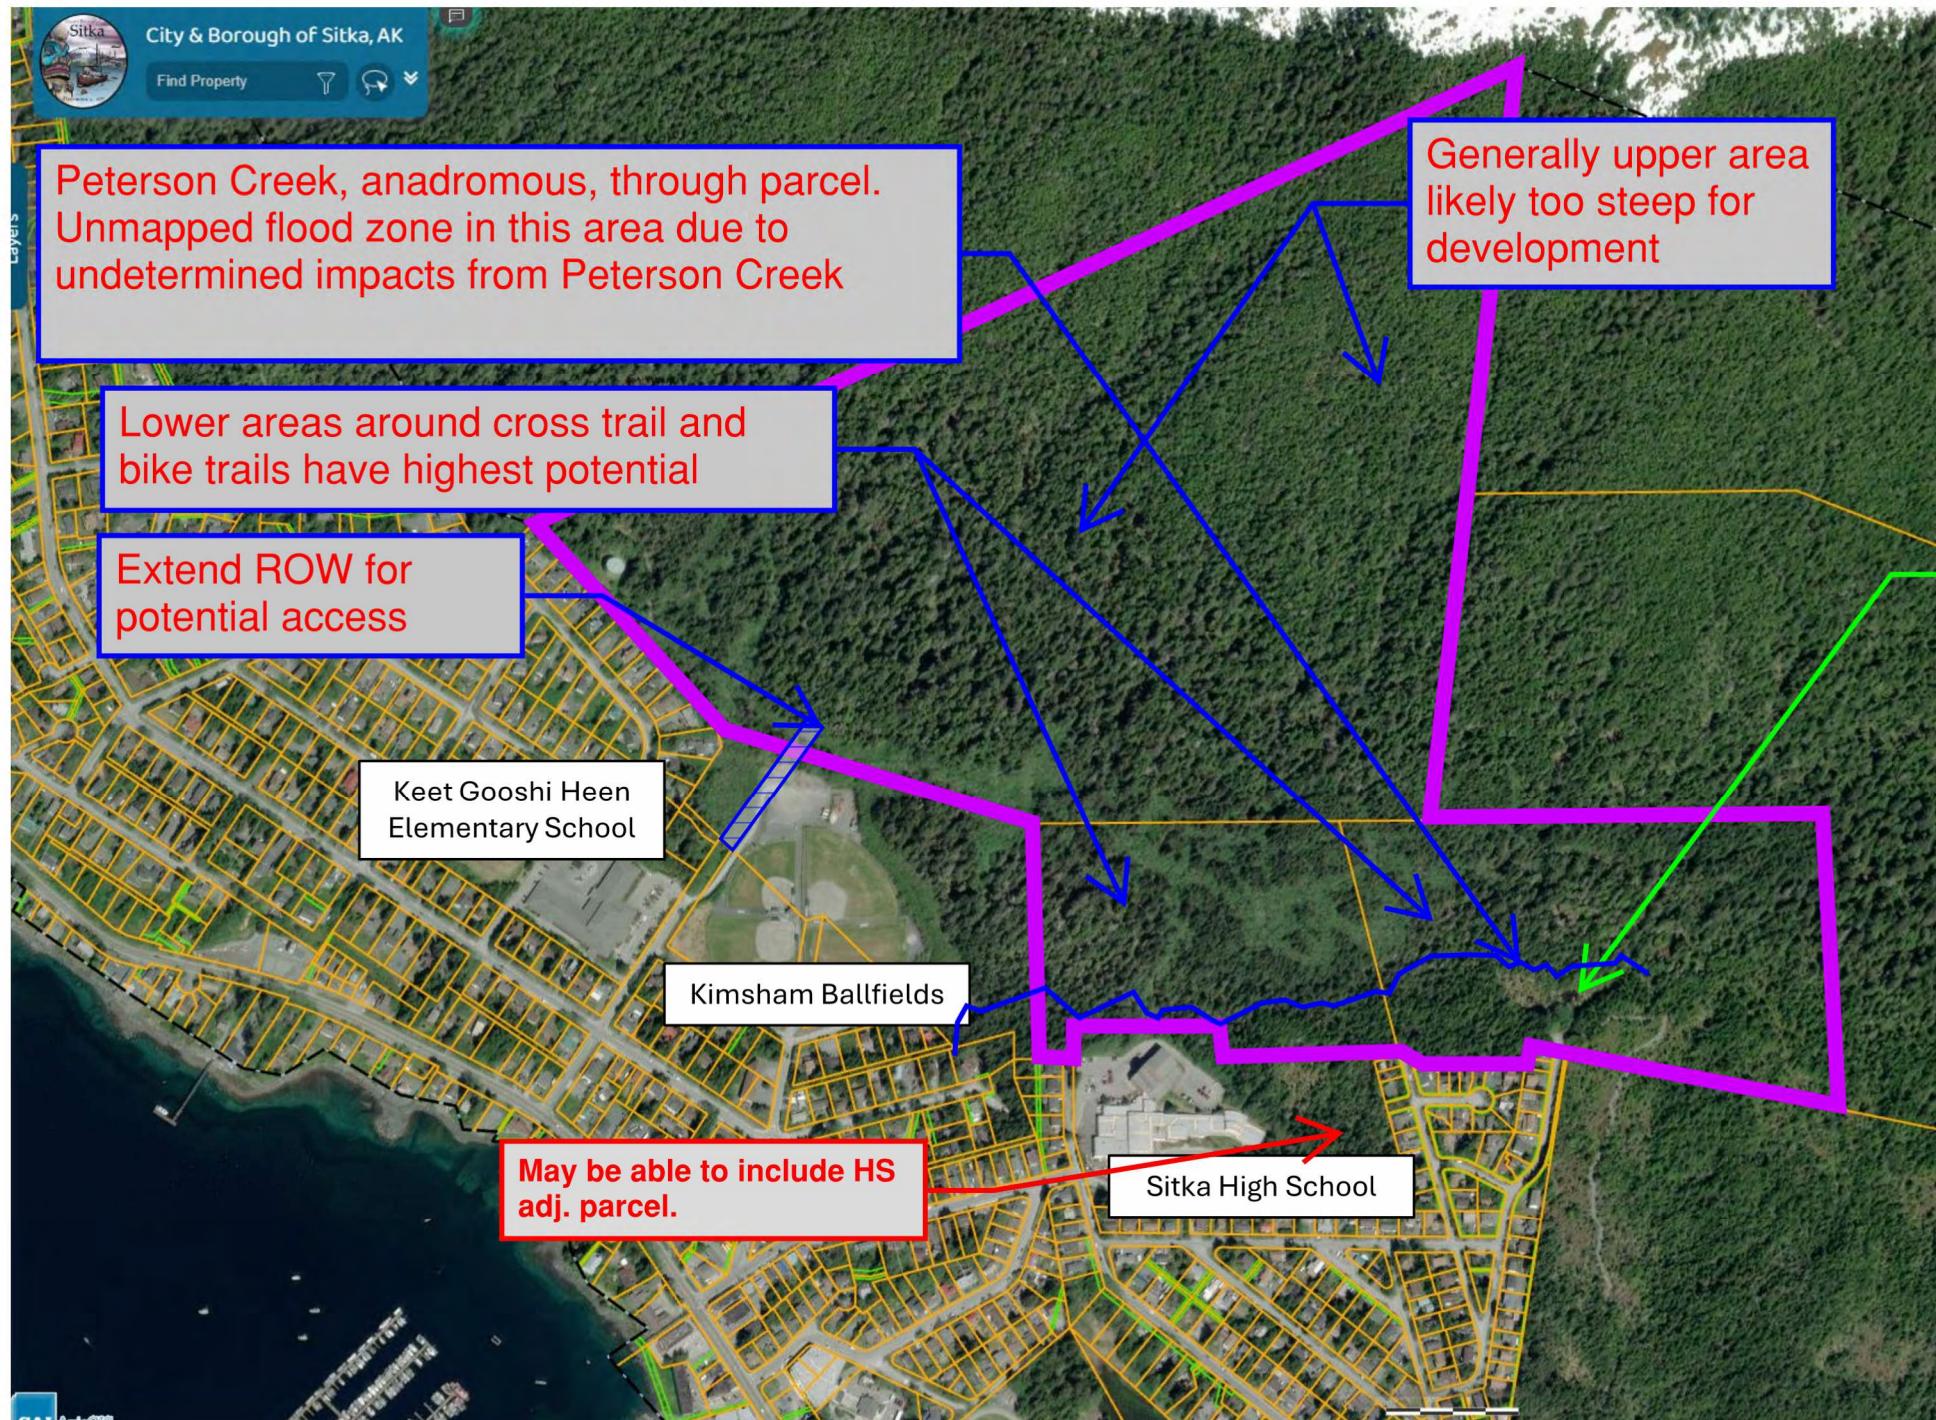
Area of Interest: Gavan Hill

1. Highest potential, more focused on smaller lots by HS, hillside may not be developable.
2. Cross trail through site.
3. Sitka trailworks will likely have input. Ben Huey receptive to development ideas.
4. Cross trail impacts and potential reconfiguration needs consideration.

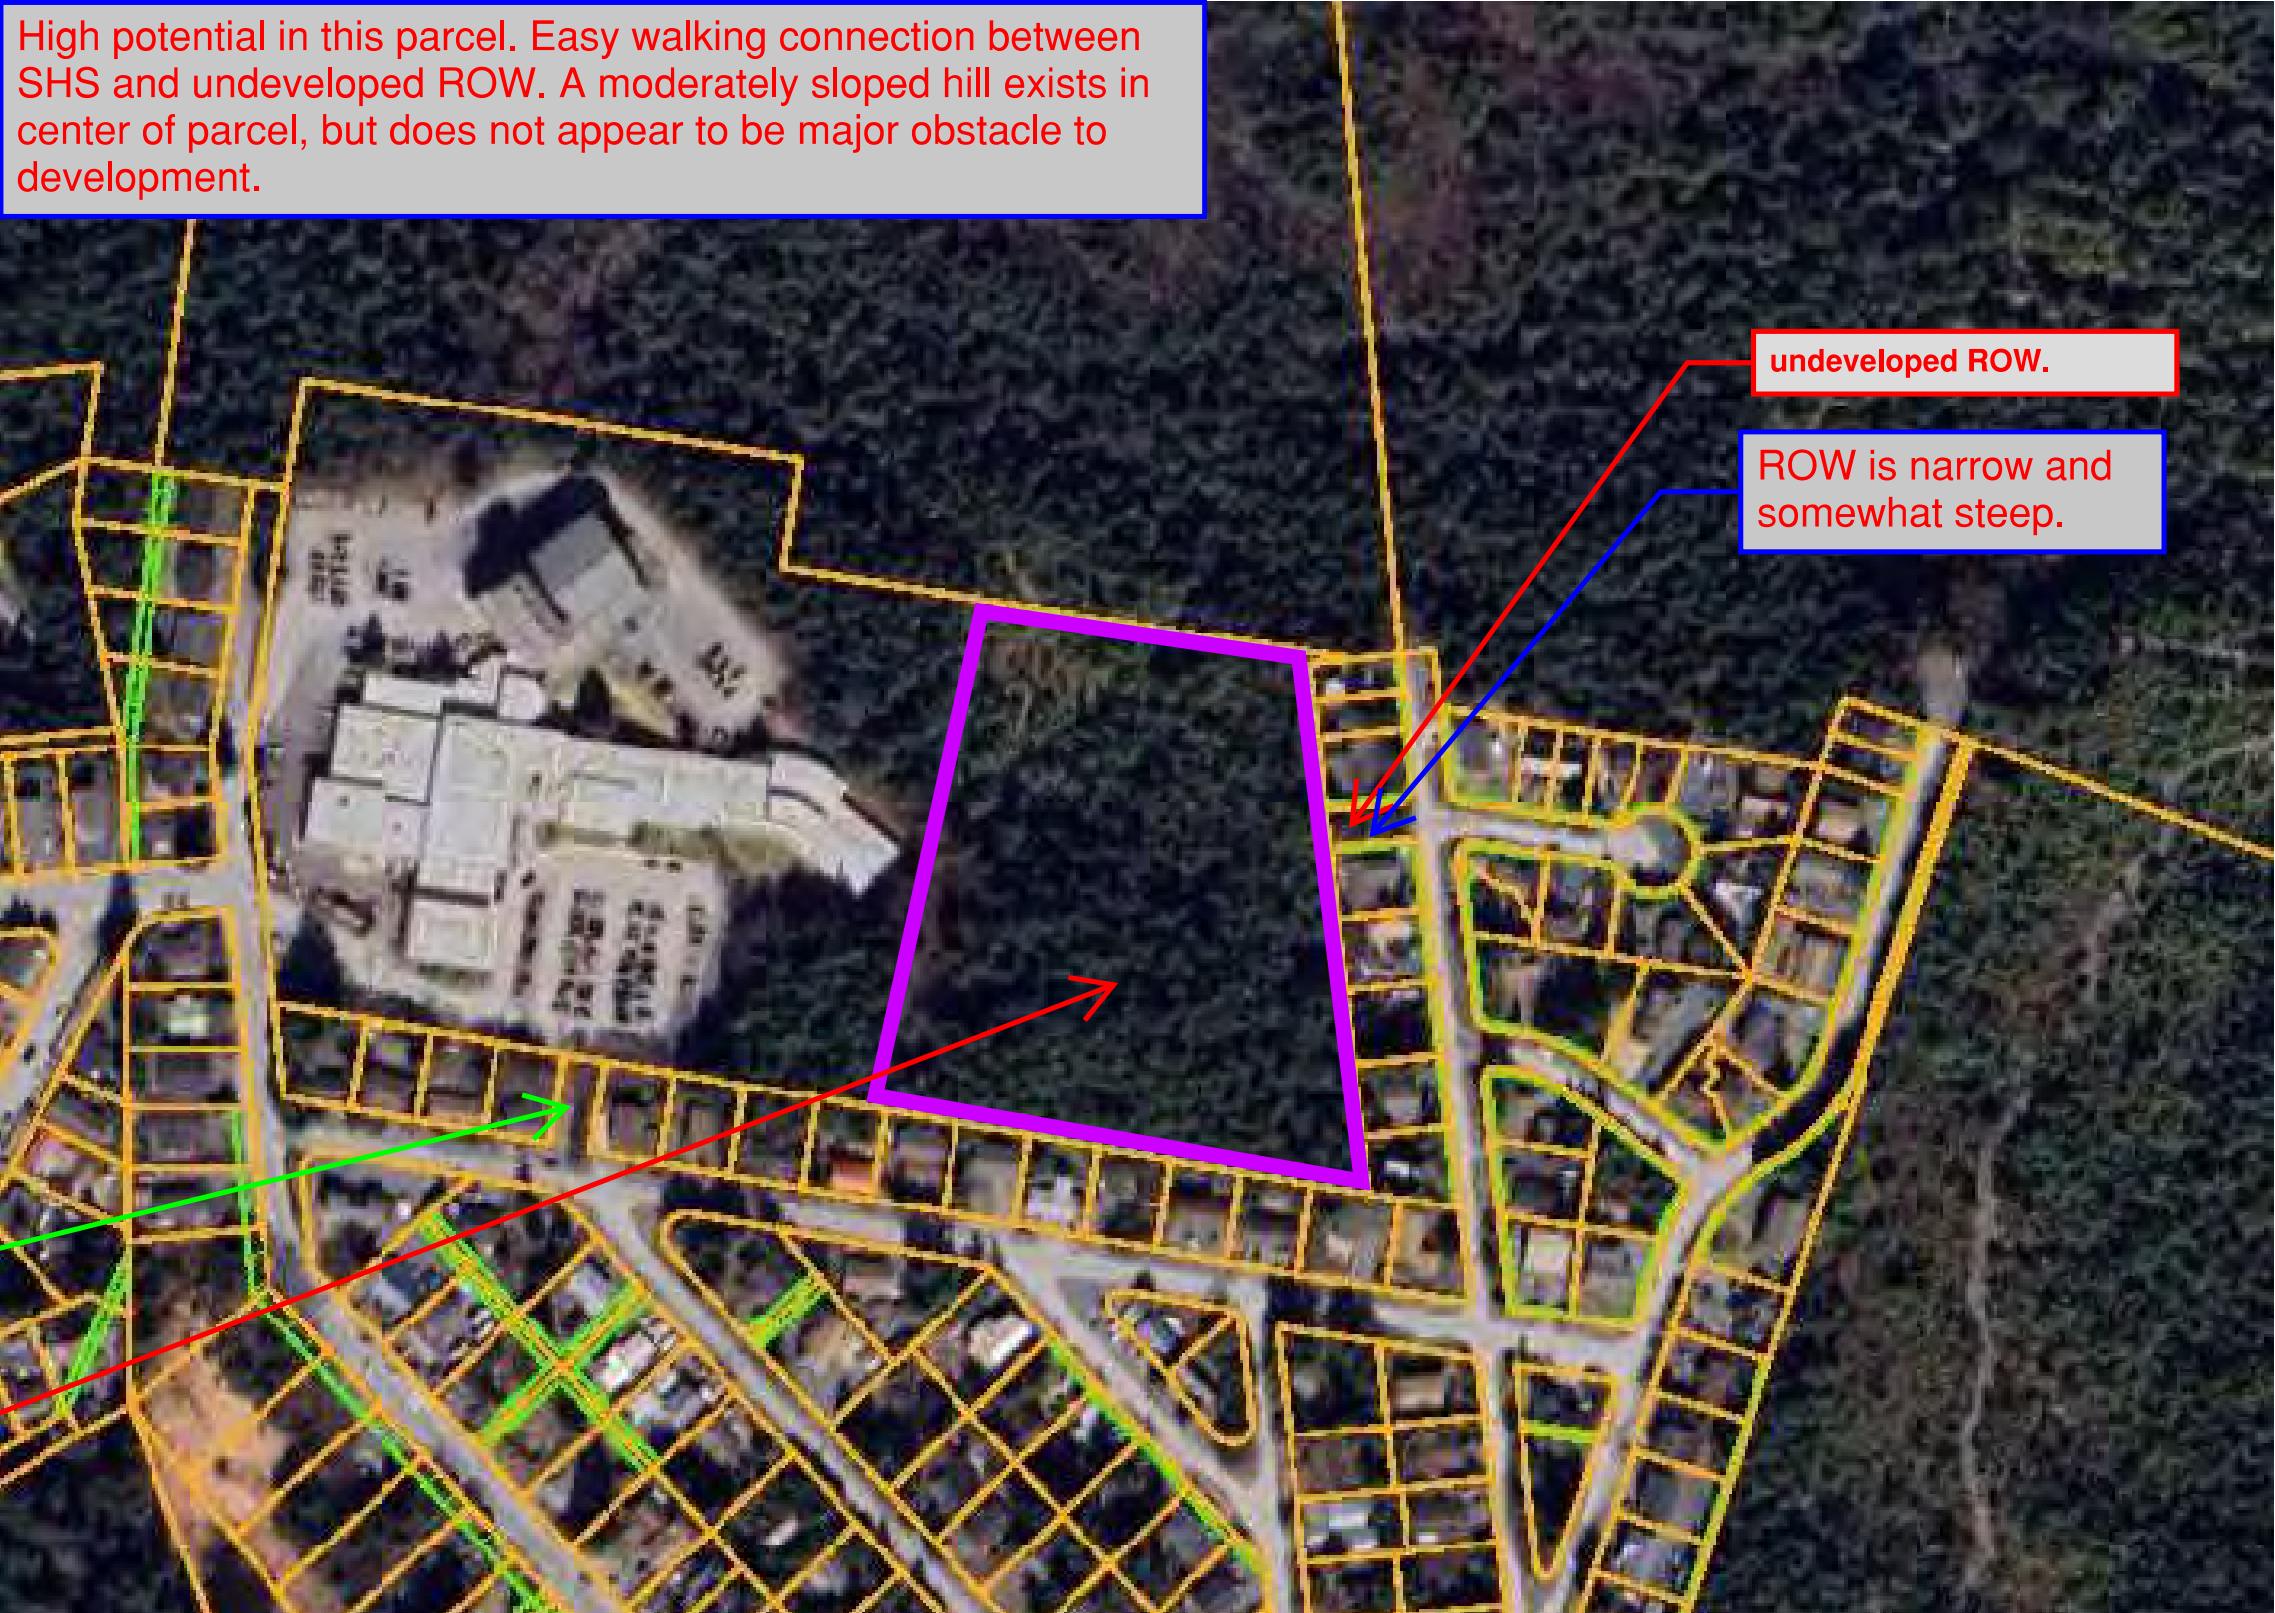
Gavan Hill - Extended

1. Cross trail
2. elevation, steep terrain.

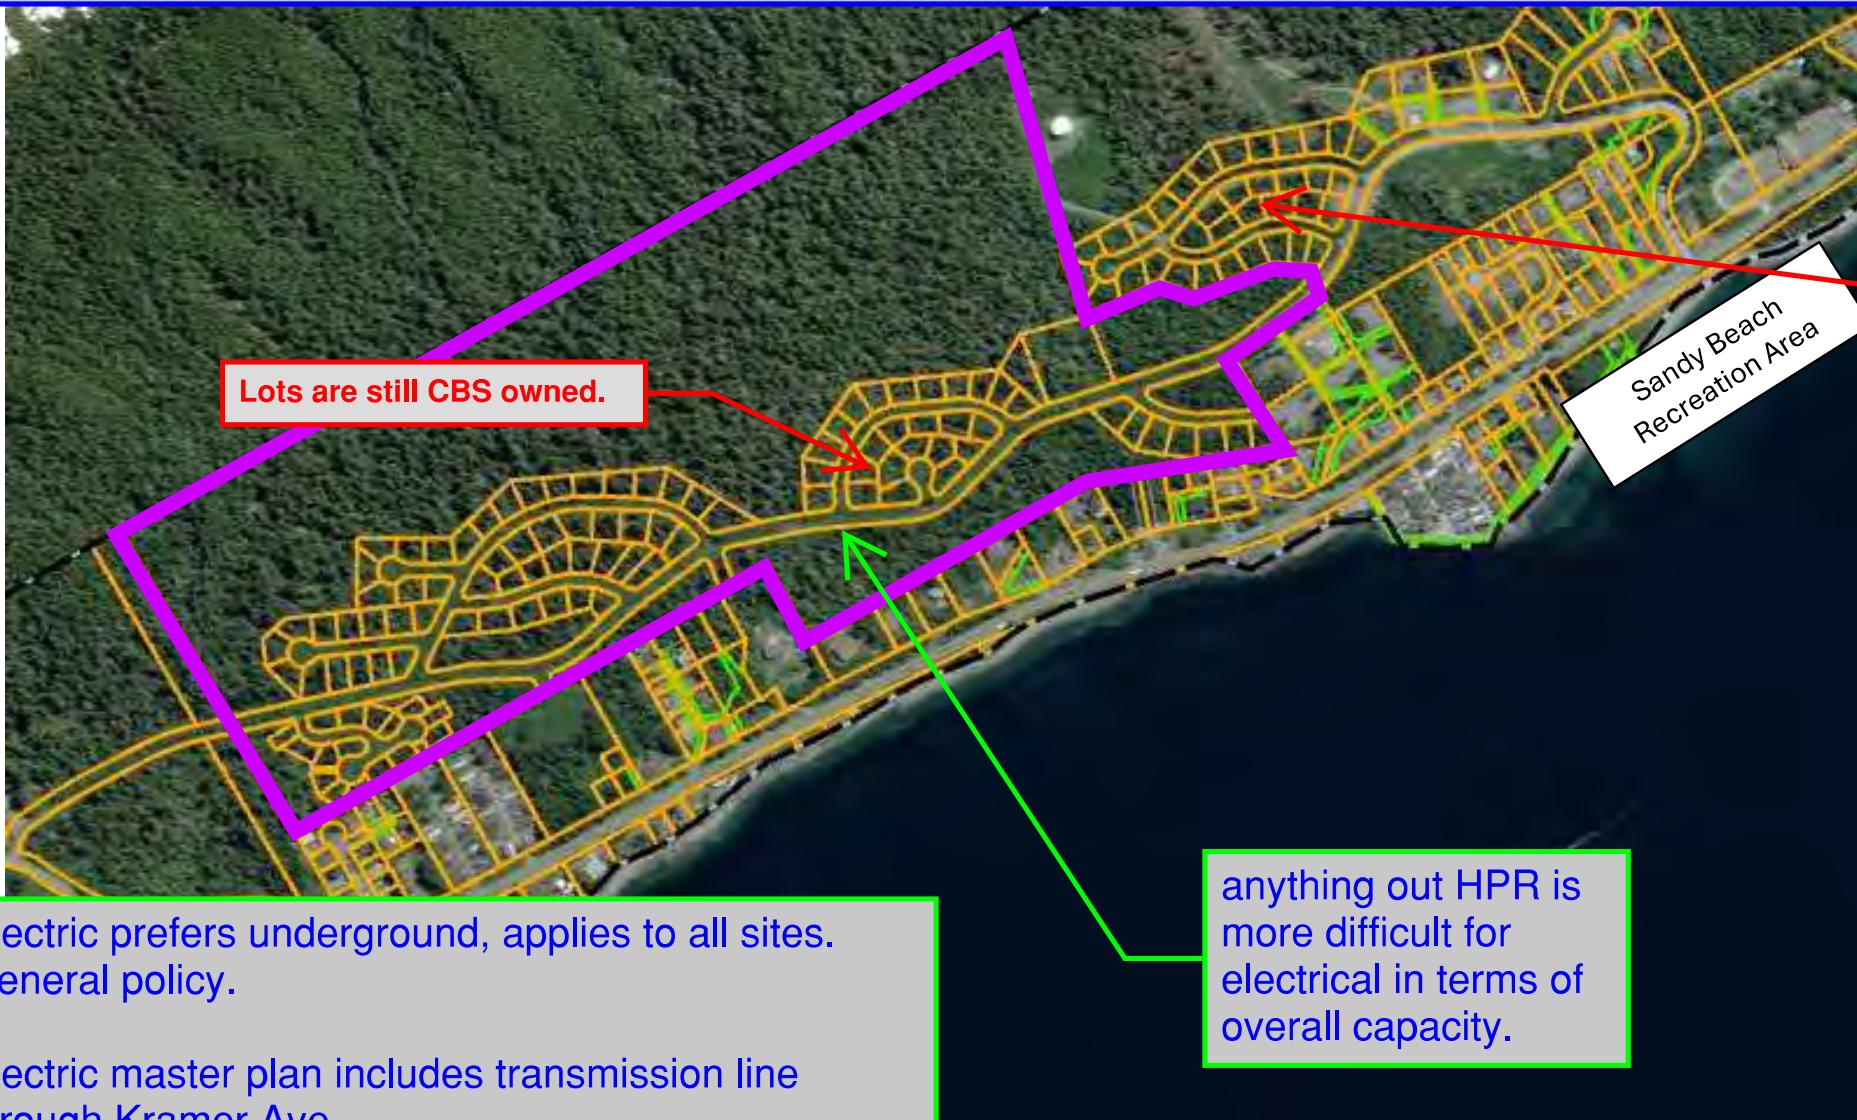
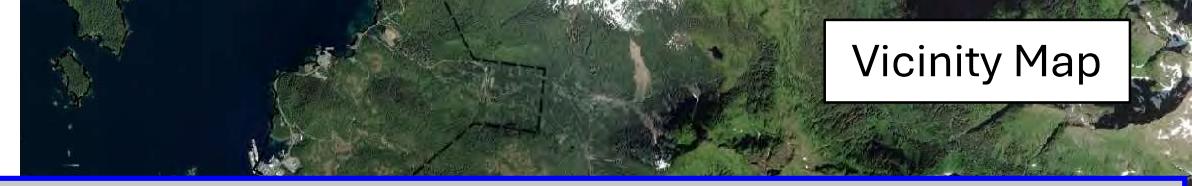
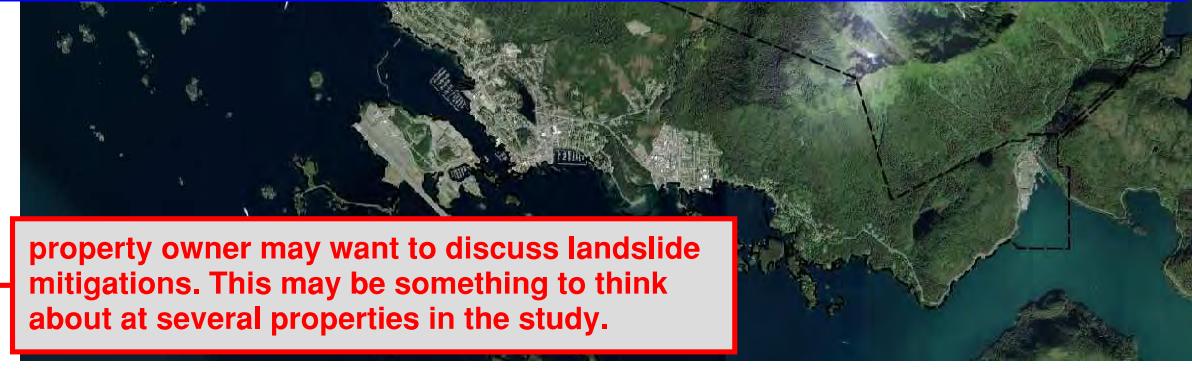
Area of Interest: The Benchlands

1. Parcels backed up against hillside seem to pose risk, areas below roadway are more promising and provide some distance from likely landslide zones. It may be feasible to move roadway nearer the hillside and dual purpose as landslide barrier opening more area to housing.
2. Based on preliminary observations and the available data, future development should be limited to the southern side of Kramer Avenue. Doing so certainly does not eliminate the risk of potentially catastrophic landslide damage, but it will reduce likelihood significantly.
3. Future landslides are likely to continue to occur upslope of Harbor Mountain Bypass Road and Kramer Avenue and there does not appear to be a feasible way to eliminate their occurrence. Instead, measures could be taken to divert and/or block landslides from reaching new developments in the Benchlands.

property owner may want to discuss landslide mitigations. This may be something to think about at several properties in the study.

Study needs to definitively tell us whether the bench lands should still be considered.

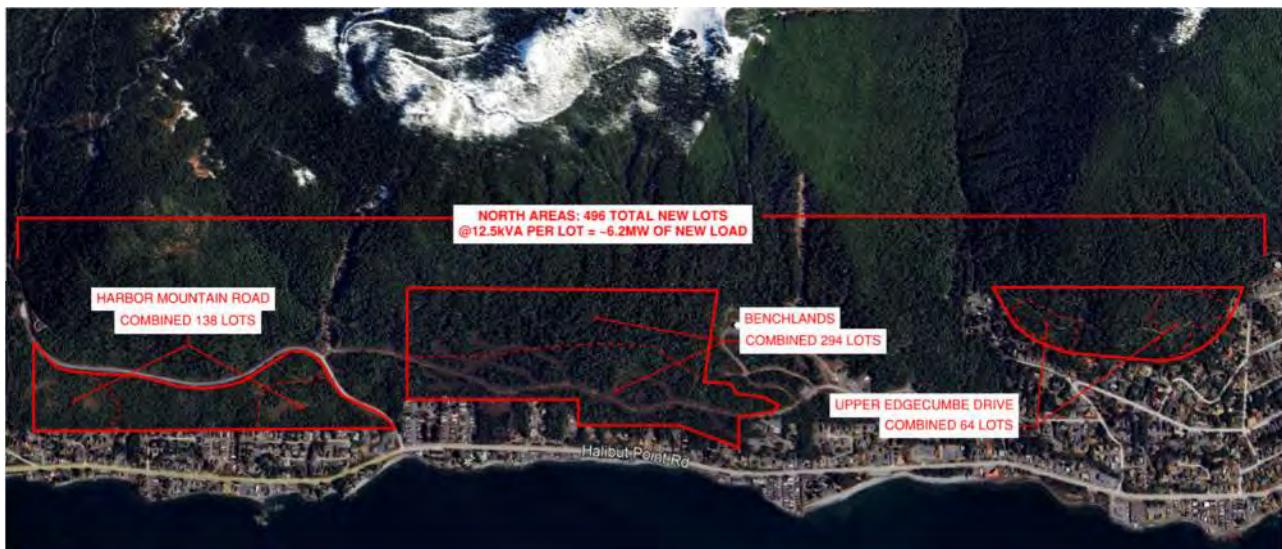
Image 1 – North Development Areas and Anticipated Lot Counts

North Areas: See Image 1 below and paragraphs in red. Here total power needs of around 6.2MW could be expected at full build-out with Benchlands the largest need at 3.7MW, Harbor Mountain Road the second largest at 1.7MW and Upper Edgecumbe Drive the third at 0.8MW. The total amount needed exceeds the capacity of two distribution feeders, and existing area feeders are already moderately loaded. If fully realized, we anticipate several new feeders being required.

Harbor Mountain Road: Estimating up to 138 new lots in several pockets developed between HPR and Harbor Mountain Bypass Road. Partial build out can likely be supported by existing area feeders, but a new feeder should be anticipated for full build out. Boxed in by HPR downhill and the Bypass Road uphill several options for feeding utility power to the zone exist. Due to its stretched shape, it lends itself to multiple tie-in points and existing overhead appears adjacent within a span in several locations. The added load is moderate and existing infrastructure is in proximity. We consider this build-out challenging.

Upper Edgecumbe Drive: Estimating up to 64 new lots in pockets developed along the hillside. Existing area feeders should have adequate capacity for this development. Located uphill from Edgecumbe Drive and the connected Charteris St., there are adjacent overhead lines which would be extended into this area with relative ease. The load added is small and existing infrastructure is in proximity. We consider this build-out least challenging.

Note about North Area Analysis: according to CBS a separate project is being discussed to extend a 69kV transmission line along Kramer Ave to a new substation in a northern location. Such an expansion could independently support most northern areas, reducing demands on Marine & Jarvis Substation.

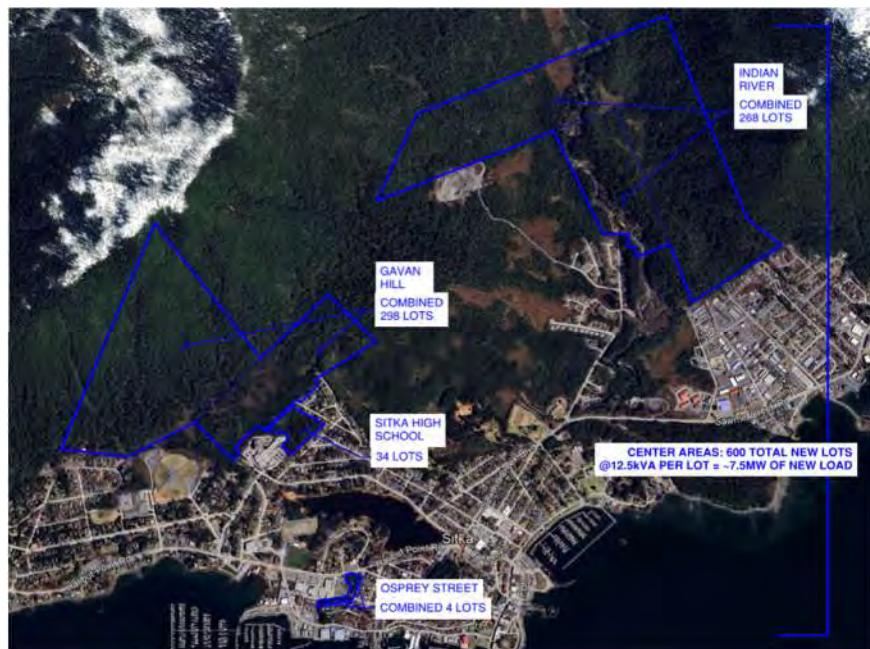
Image 2 – Center Area Developments and Anticipated Lot Counts

Central Areas: See Image 2 below and paragraphs in **blue**. Total power needs are 20% higher than the full north zone with a 7.5MW load anticipated for the 600 new lots. While existing central area feeders do have more available capacity vs. the existing north feeders, new feeders would be required to accommodate the complete build out of central developments.

Sitka High School: Estimating up to 34 residential units likely in a higher density configuration due to the small landlocked location. Area feeders have sufficient capacity for this full build. The location is within close proximity to existing utility that can be extended as required. The new load is small and existing overhead is within proximity. We consider this build-out **least challenging**.

Osprey Street: Estimating 4 new lots developed in the skinny plot east of the Middle School. Several area feeders are available and should have sufficient capacity to serve. Existing utility is adjacent and can be extended as required. The new load here is small and existing overhead is within proximity. We consider this build-out **least challenging**.

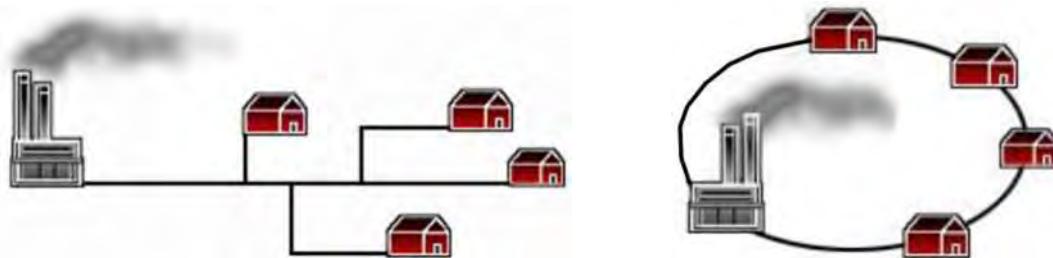
Image 4 - Radial (left) and Loop (right) network systems

3. **Loop vs. radial network systems.** Dual electric utility feeds, as recommended in Item 2 above, will require transformers to be loop fed. See Image 4 below for a comparison between loop and radial systems. Loop systems provide the means to push power from either direction, providing better continuity of service than radial systems. A power failure, short-circuit, or downed power line in a radial system would interrupt power to all lots fed via a radial distributed system. Where power is provided to cul-de-sacs and dead-end streets it is less expensive to use radial connected transformers and more justified since power outages are less impactful, we recommend that only loop fed transformers are used and the underground distribution is designed for loop networks, including conduits in & out of all transformers. See below graphical comparisons.

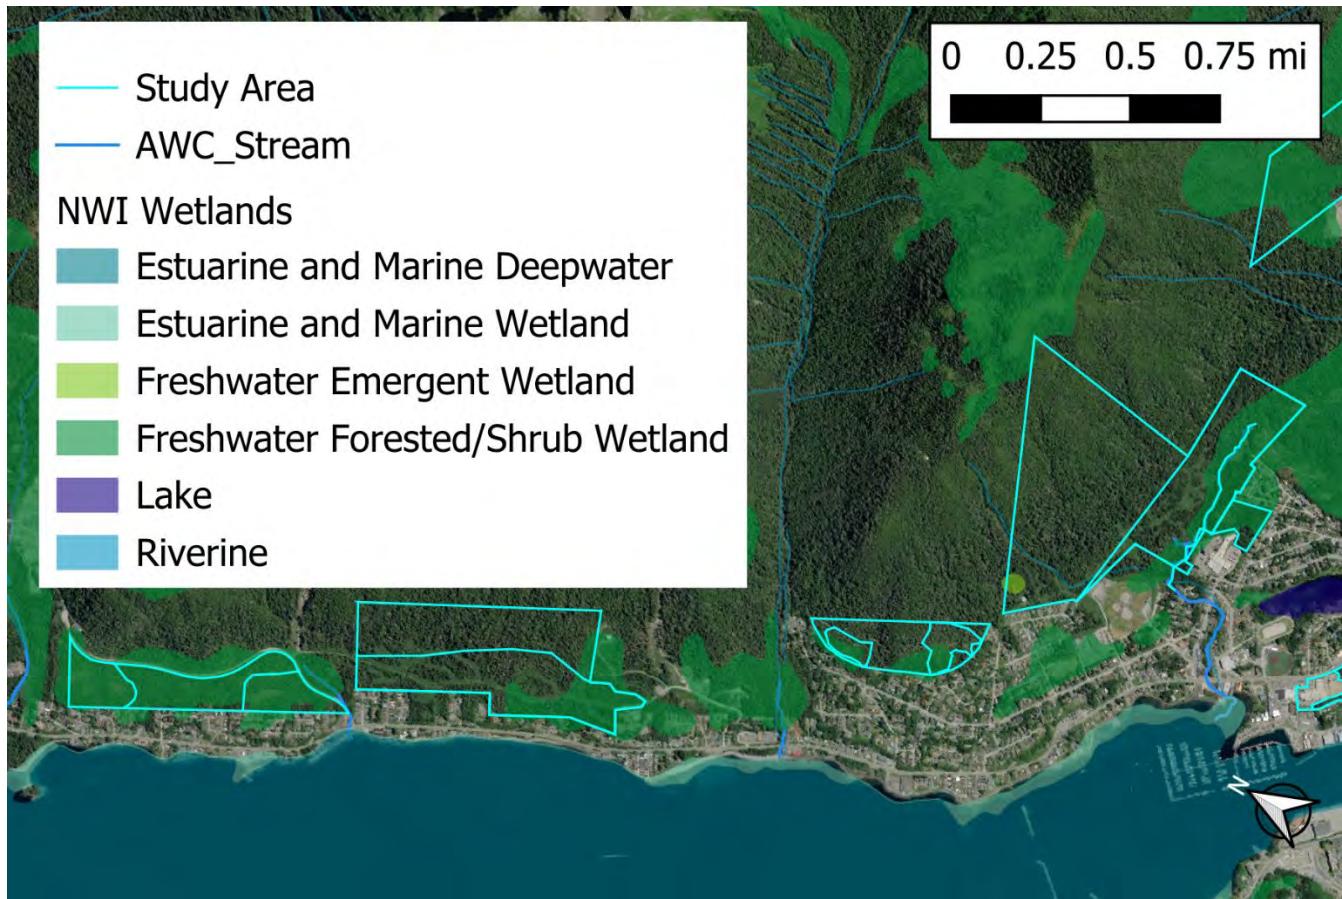
Figure 2. Parcels Targeted for Wetland Reconnaissance With NWI-Mapped Wetlands

USFWS NWI mapping uses a single-parameter methodology and is often solely based on aerial imagery, often overestimating wetland areas. Inconsistencies between field findings and NWI mapping are likely attributed to this.

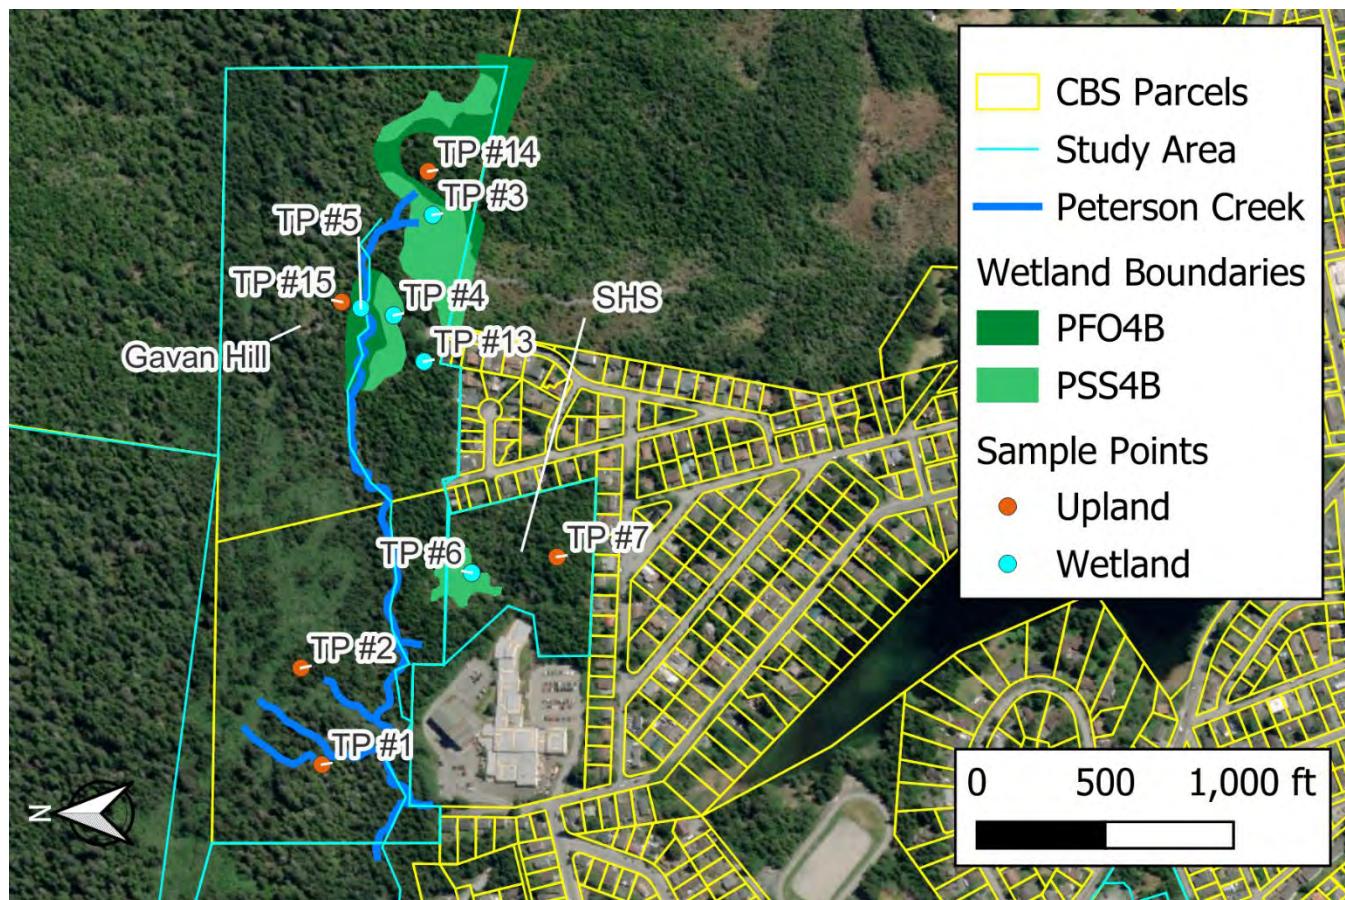
Figure 7. Gavan Hill and SHS Delineated Wetland Boundaries, Sample Points, and Streams

Boundaries between the wetland and upland areas were mapped based on differences in vegetative communities, with the use of a soil auger, micro-topography, and hydrology observations for confirmation. Upland areas throughout the study area generally included a greater number and higher coverage of FACU species, which differentiated them from the observed wetland vegetative communities.

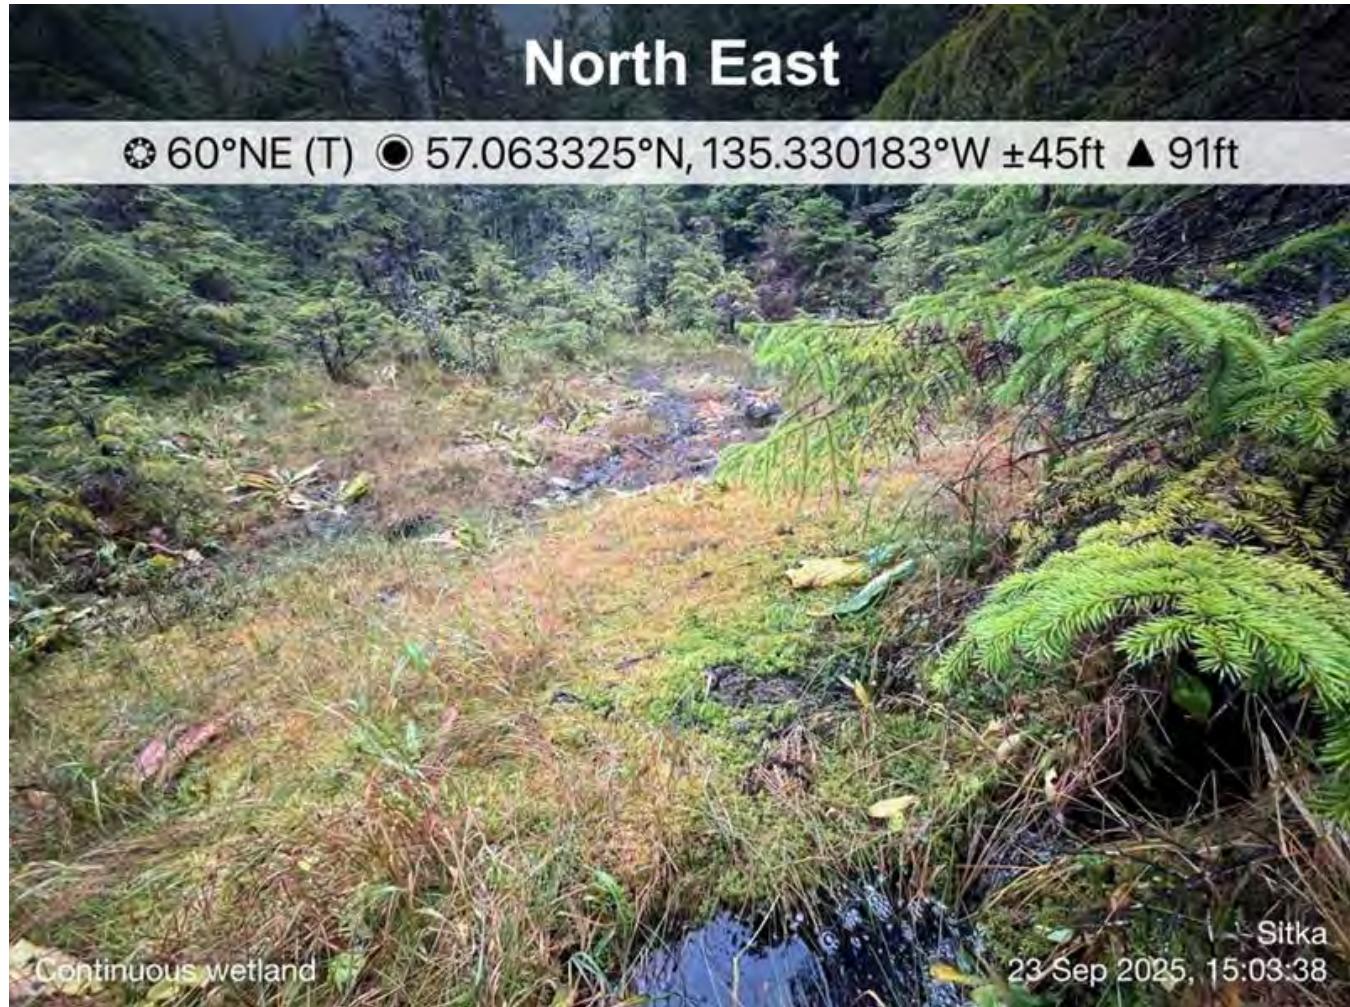
Figure 8: Surface Water Visible at a Wetland Site

Prolonged heavy rains likely influenced hydrology indicators; however, that weather is typical during September in Sitka.

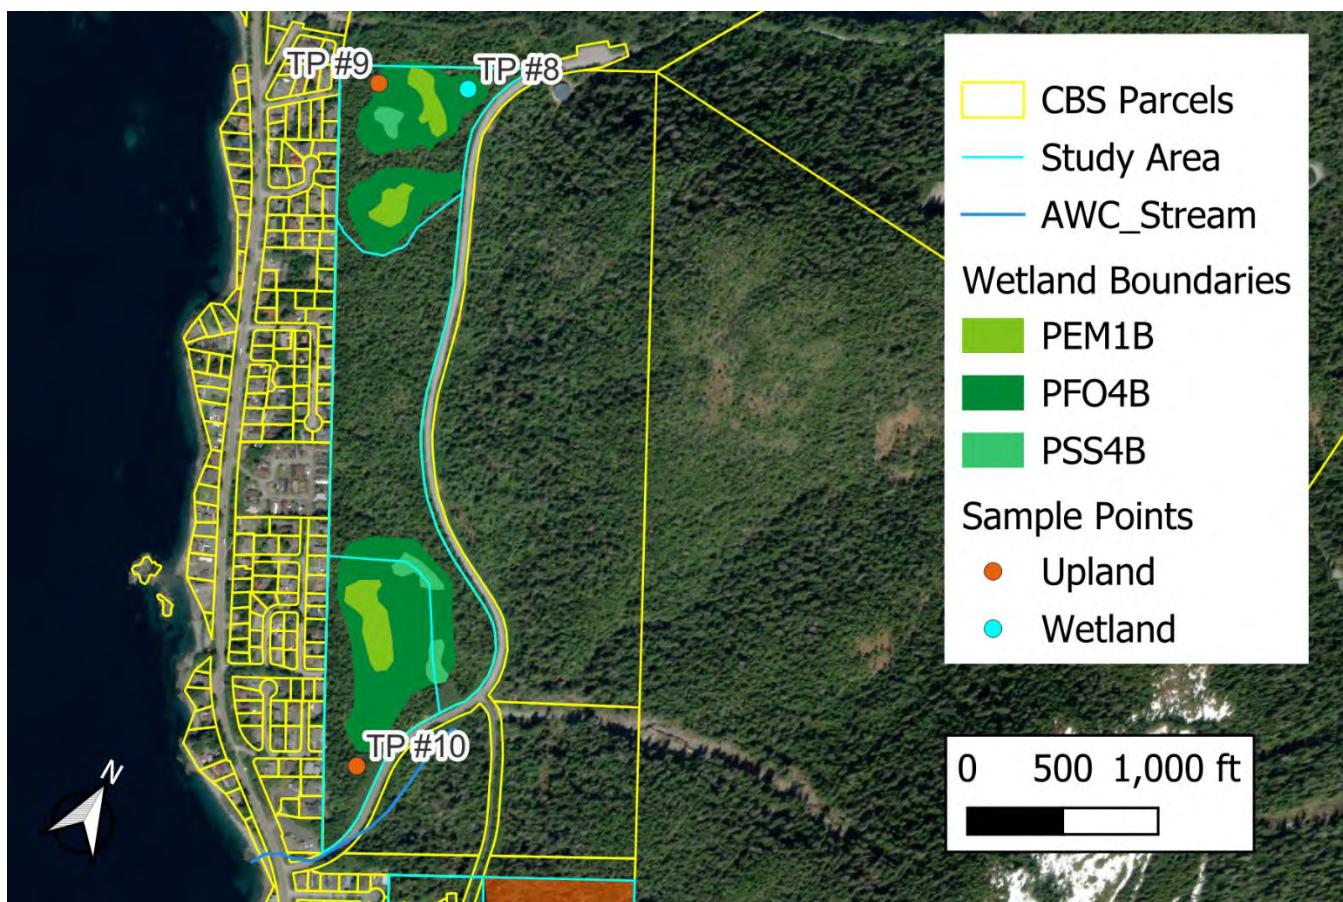
Figure 9. Sample Points and Approximate Wetland Boundaries at Harbor Mountain Road

Wetland mapping at Harbor Mountain Road relied heavily on inferences made in the field and desktop information to supplement field samples, refer to Figure 9. Both sample plots and rapid sampling using a soil auger and visual estimations of vegetation cover were used as aids in mapping, but field efforts were limited due to time and budget constraints. It should be noted that the wetland/upland boundary at Harbor Mountain Road is highly ambiguous because of similarities in vegetation throughout the area and micro-topographical features with variable hydrology. Further study is needed at this parcel to accurately determine wetland boundaries.

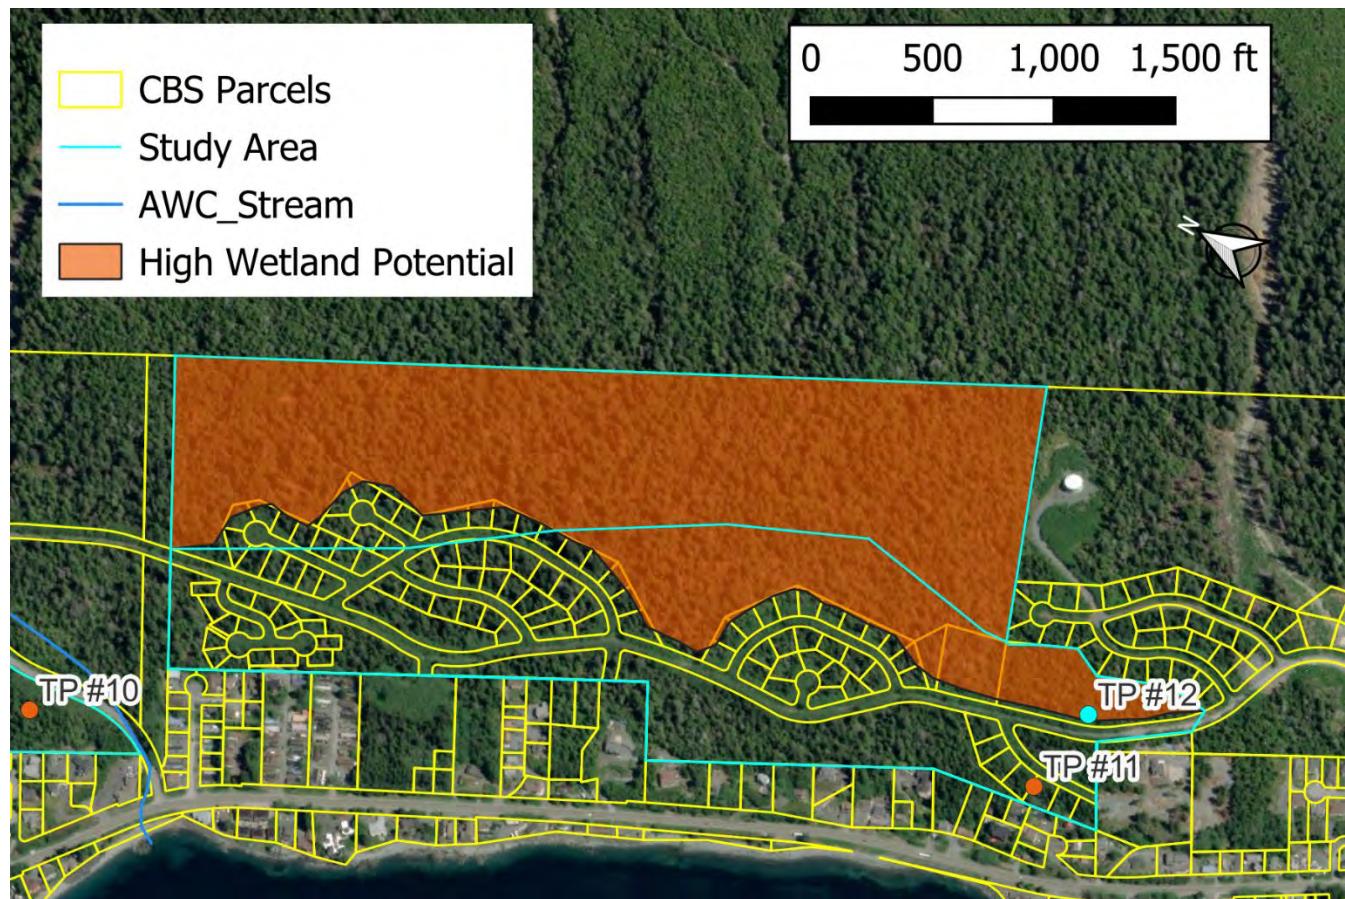
Figure 10. Area of High Wetland Potential at the Benchlands Subdivision.

Vegetation upslope from the platted lots and roads at the Benchlands subdivision was visually observed from the roads to be consistent with forested wetlands at Harbor Mountain Road (i.e., tree stratum dominated by Alaska cedar, relatively open canopy). A sample plot with vegetation representative of what was observed remotely in that area was confirmed to meet criteria for hydrophytic vegetation (W-TP12). This area is presumed to have a high likelihood of wetland presence (Figure 10). Further investigation at the Benchlands was halted during the survey due to heavy rains and landslide risk. Investigators hold the opinion that the subdivision was designed, in part, to avoid wetlands.
